CASE STUDY: [REDACTED]

Sanitation Capabilities of the airPHX System in a Typical Gym Environment – [REDACTED]

In-Treatment Air and Surface Report – [REDACTED] Large Workout Area

Pre-Treatment Air and Surface Report – [REDACTED]

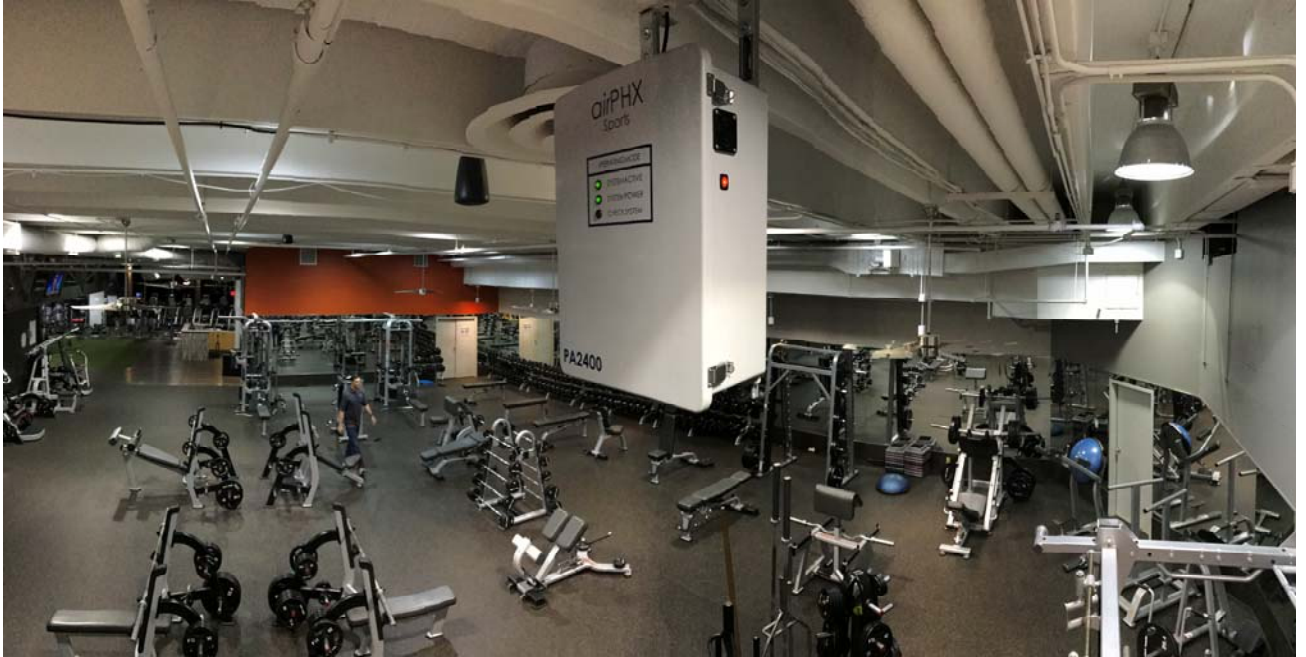
Installed Unit

Four ceiling mounted PA2400 units were installed in late October 2016. Units were programmed to activate one hour after the gym closed and to shut down one hour prior to opening – for many nights, this schedule meant the units operated for only four hours from midnight to 4 am. To increase the effectiveness of the units, they can be run at longer intervals including 24/7 to achieve maximum effect.

ROS treatment was carried out using four (4) airPHX, PA 2400 suspended from the ceiling in opposing corners of large workout room and activated.

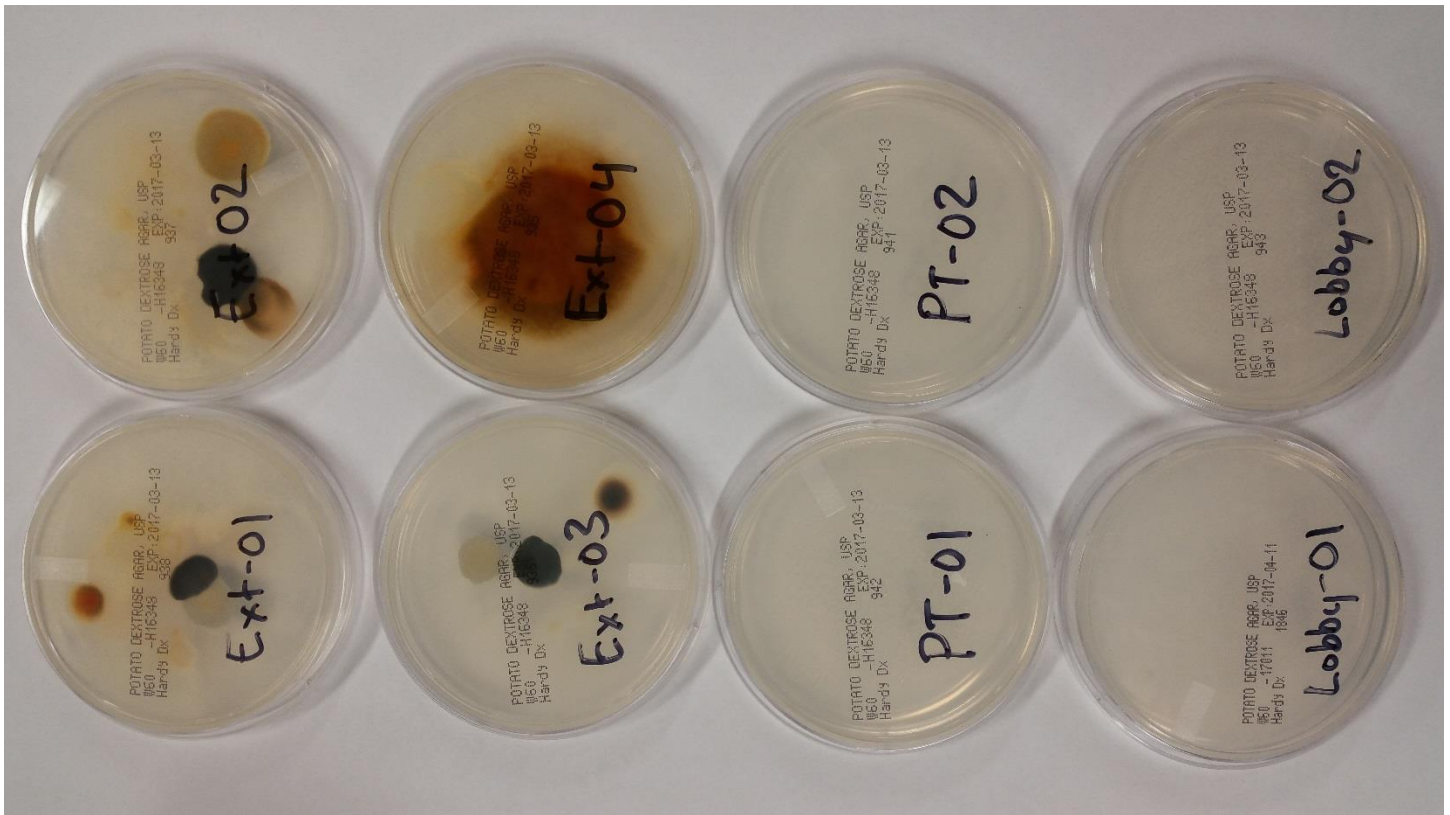
Outside air, PT and Lobby Air Samples

All air samples were taken via the MB-2 air sampler, 30 liters per sample throughout the various locations given above with results normalized to colony forming units per cubic meter of air (CFU/m³).

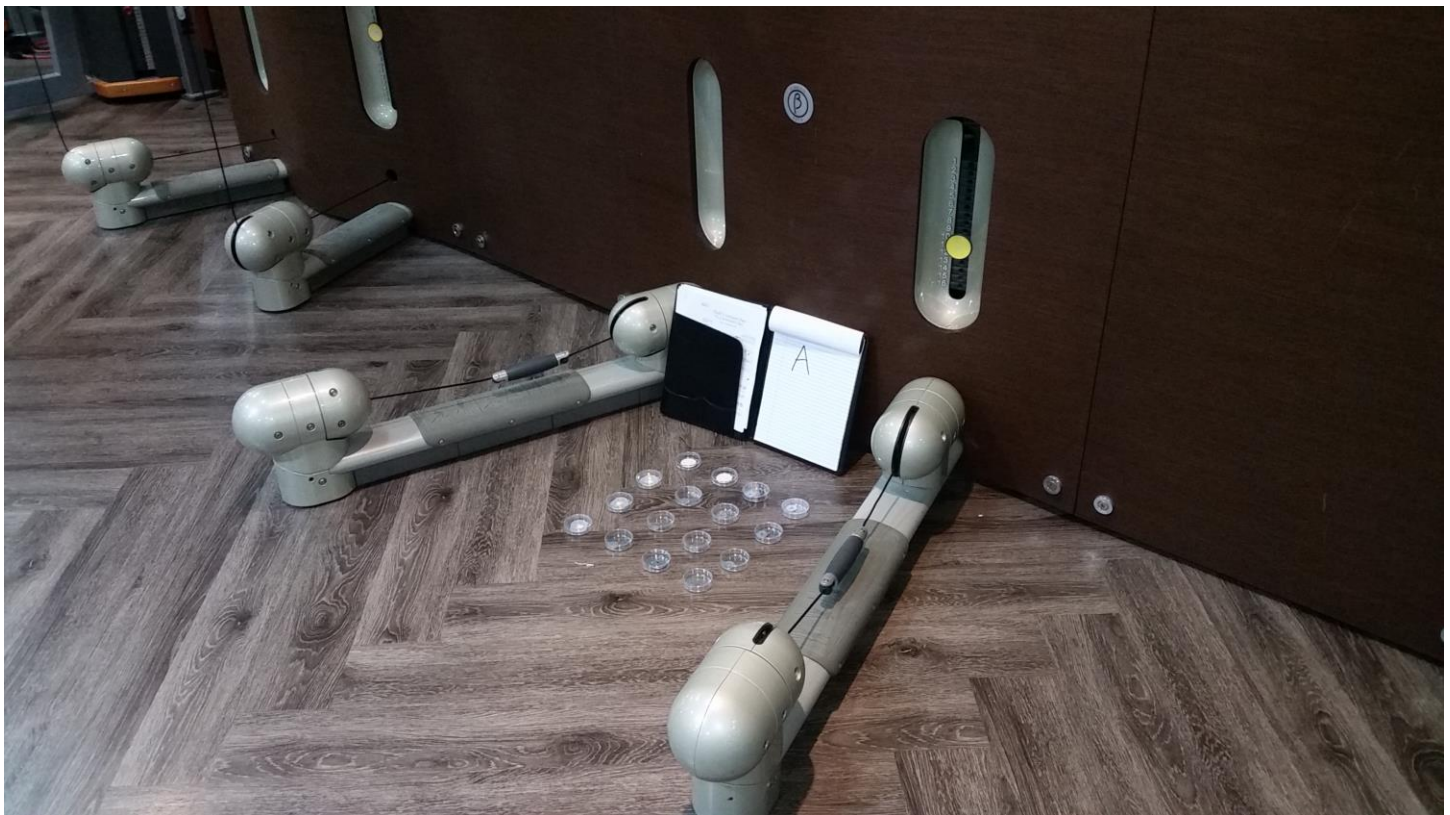
Stainless Steel and Plastic Coupon Location A

Approximately 100, 5mm stainless steel and plastic inoculated coupons (~50 each) were randomly placed (different locations) and was treated with airPHX system, see pictures attached. Samples were randomly harvested from each location after exposure of one (1) hour and then in one (1) hour increments for four (4) hours from the large workout room at ordinary maintained temperatures. Post treatment, all samples were subjected to enumeration by surface plating. The log reduction of the inoculum was evaluated with and without the consideration of resuscitation of injured cells after ROS treatment.
