BSW Group LLC
7823 Village Drive
Knoxville, TN 37919

Pre and In-Treatment Air and Surface Report – [REDACTED] Church

A. Summary – Air Samples

B. Summary – Surface Contact Swabs

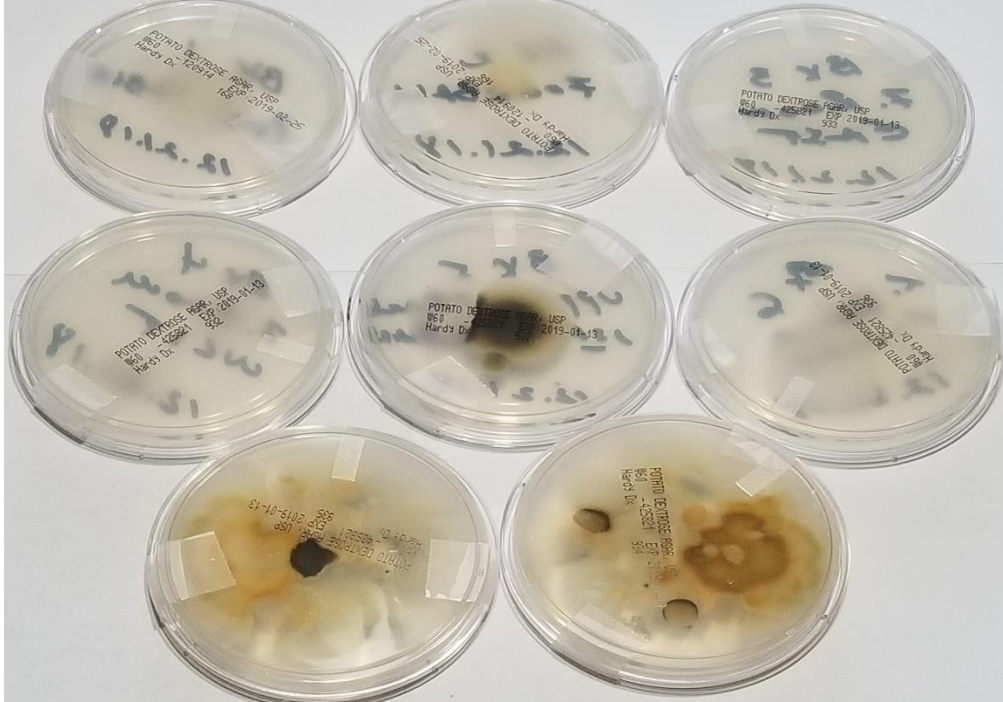
Table #3

In-treatment 12/21/18 bioburden in the sampled locations show a **91.2% reduction** and are **now < 100 cfu/m³** and are considered **clean and acceptable**.

Church
Air Sample Pictures

12/21/18 In-treatment

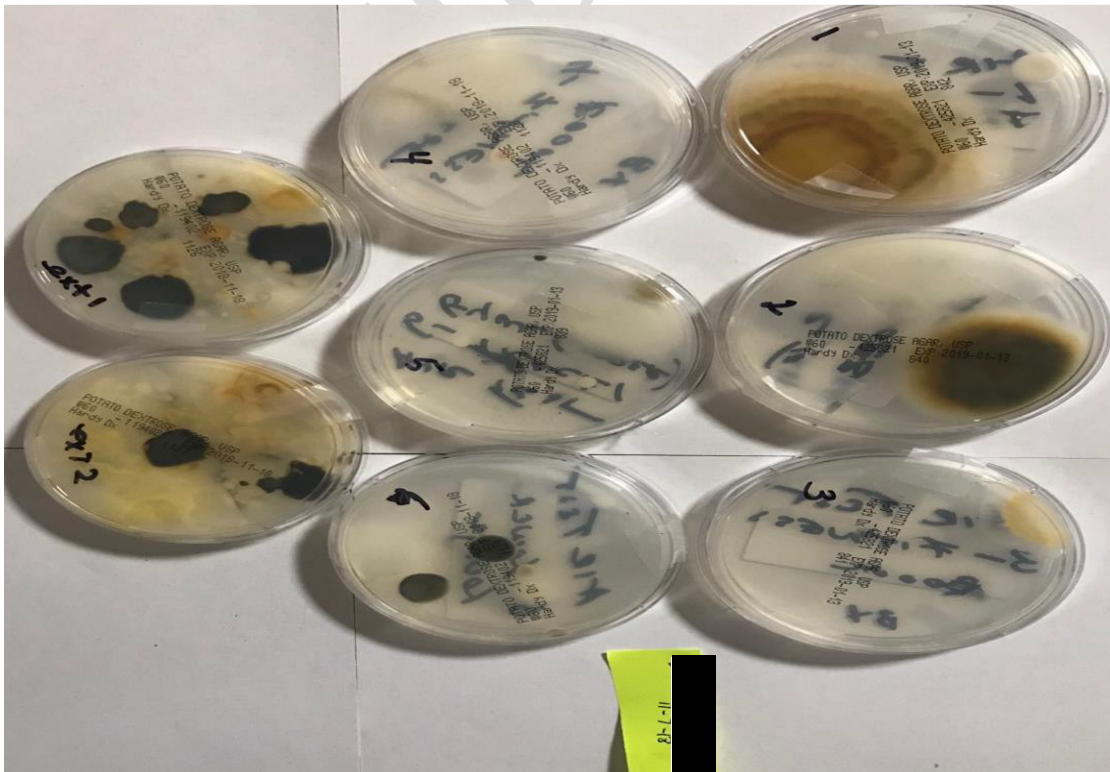
11/07/18 Pre-treatment

Pre-treatment 11/07/18 bioburden in the sampled rooms are significantly above > 300 cfu/m³, which is not acceptable and needs corrective action.

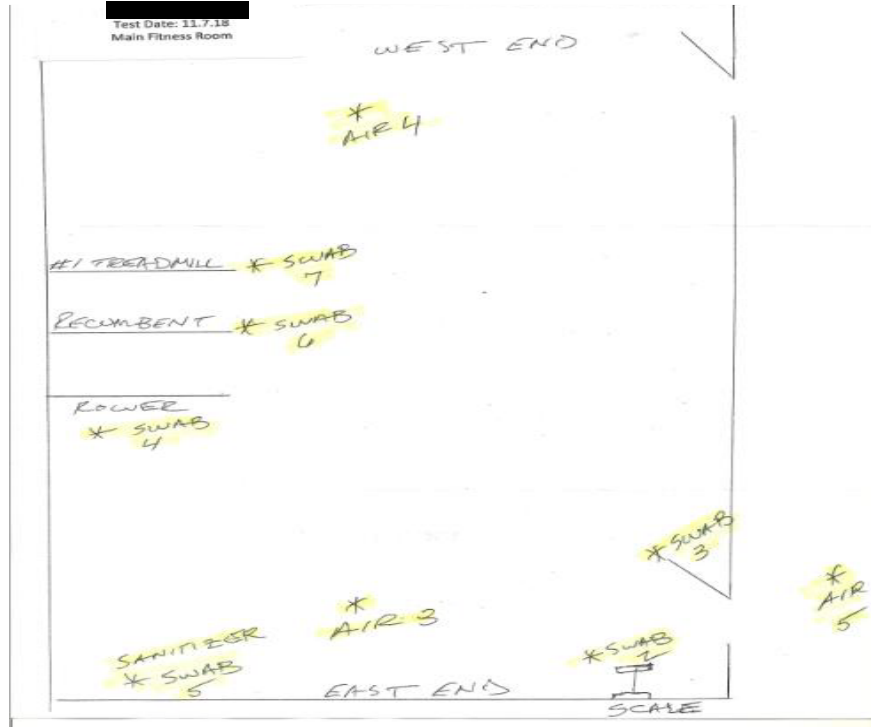
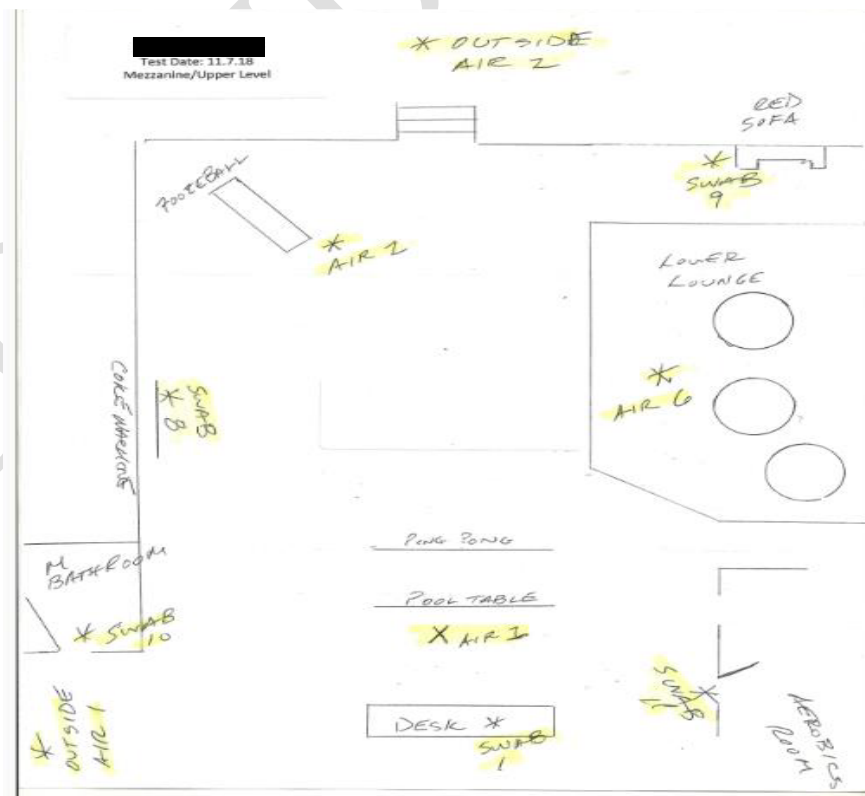
Table #4, continued
Church
Pre-treatment Air Sample Location Map

11/07/18 Pre-treatment
