BSW Group LLC 7823 Village Drive Knoxville, TN 37919 November 19, 2019

Pre and In-Treatment Air and Surface Report – University

| - Equipment Room

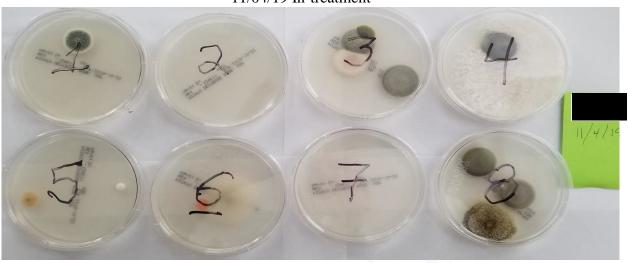
Table #3

11/04/19 – In-treatment set of samples post a 93.2% reduction and is < 100 cfu/m³ which is considered clean and acceptable.

Air Sample Pictures

11/04/19 In-treatment

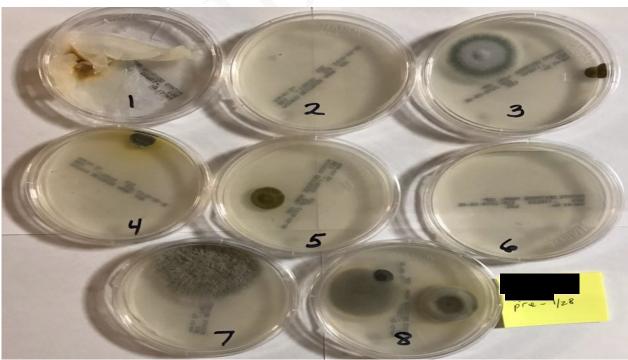
Table #3

01/28/19 – Pre-treatment bioburden in the sampled rooms are considerably above > 300 cfu/m³, which is not acceptable and needs corrective action.

Air Sample Pictures

01/28/19 Pre-treatment
