***CASE STUDY: CYPRESS FITNESS  
MCLEAN, VIRGINIA***

## In-Treatment Report – Cypress Gym - Final

## Pre-Treatment Report – Cypress Gym

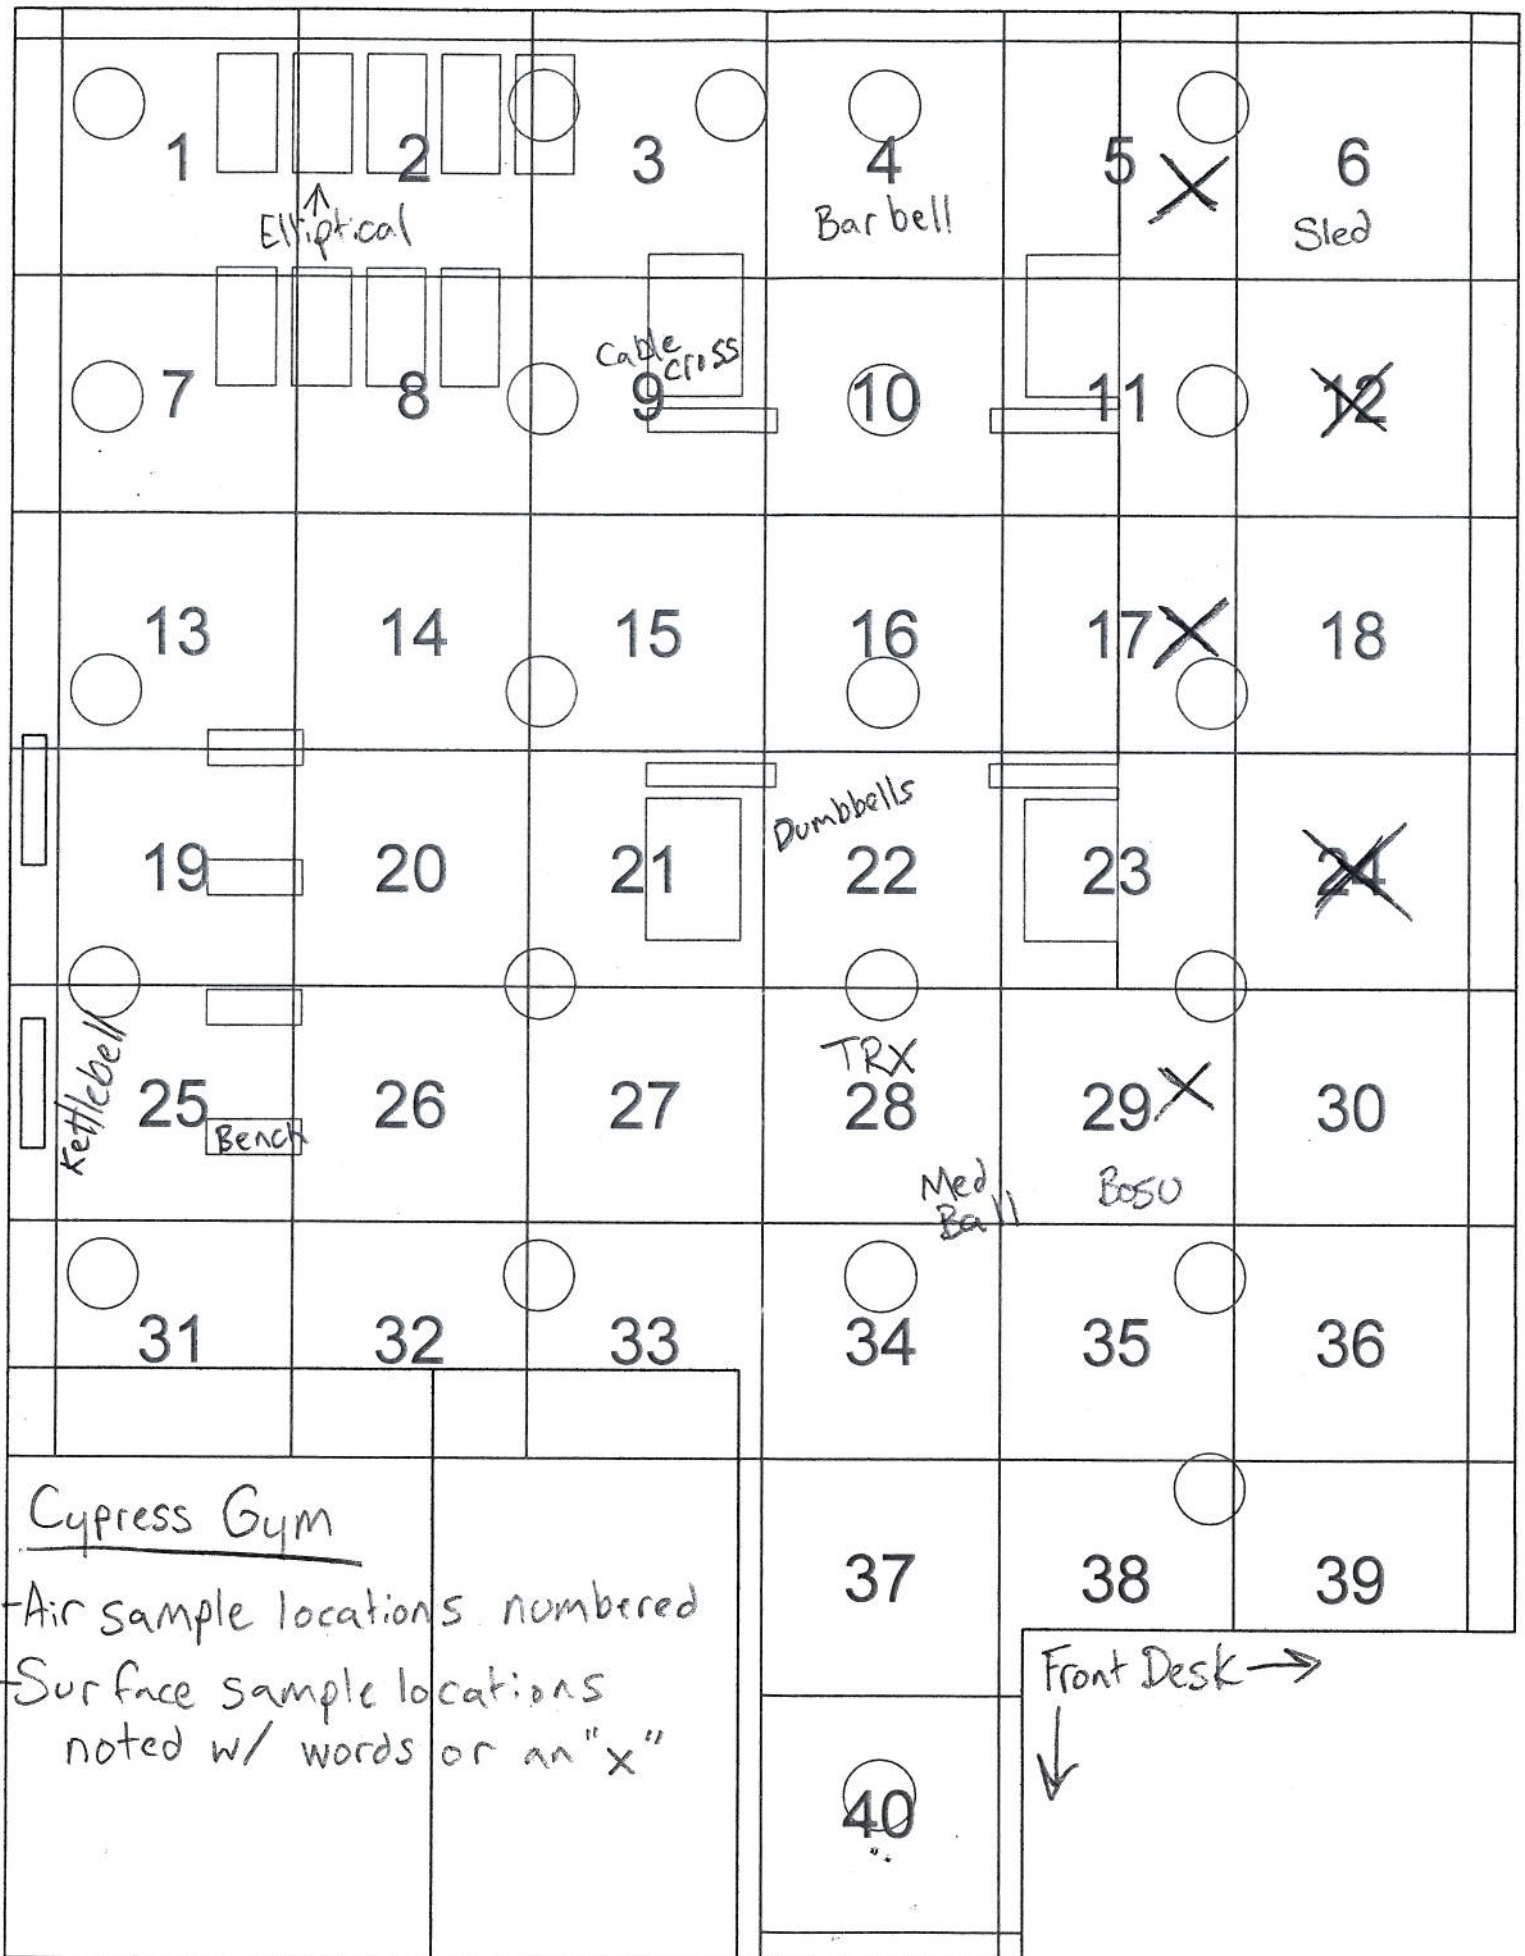
# Cypress Gym - Air and Contact Swab Locations

Pre-treatment air and contact swab samples were taken 05/11/16 with average results given below and results by location for air samples in Table #1 and results for contact swab samples in Table #2. Also attached is the air and physical sample location map.
